Pirton's Small Timber Framed Domestic Buildings

H.L.F. Community Project

THREE GABLES

Crabtree House

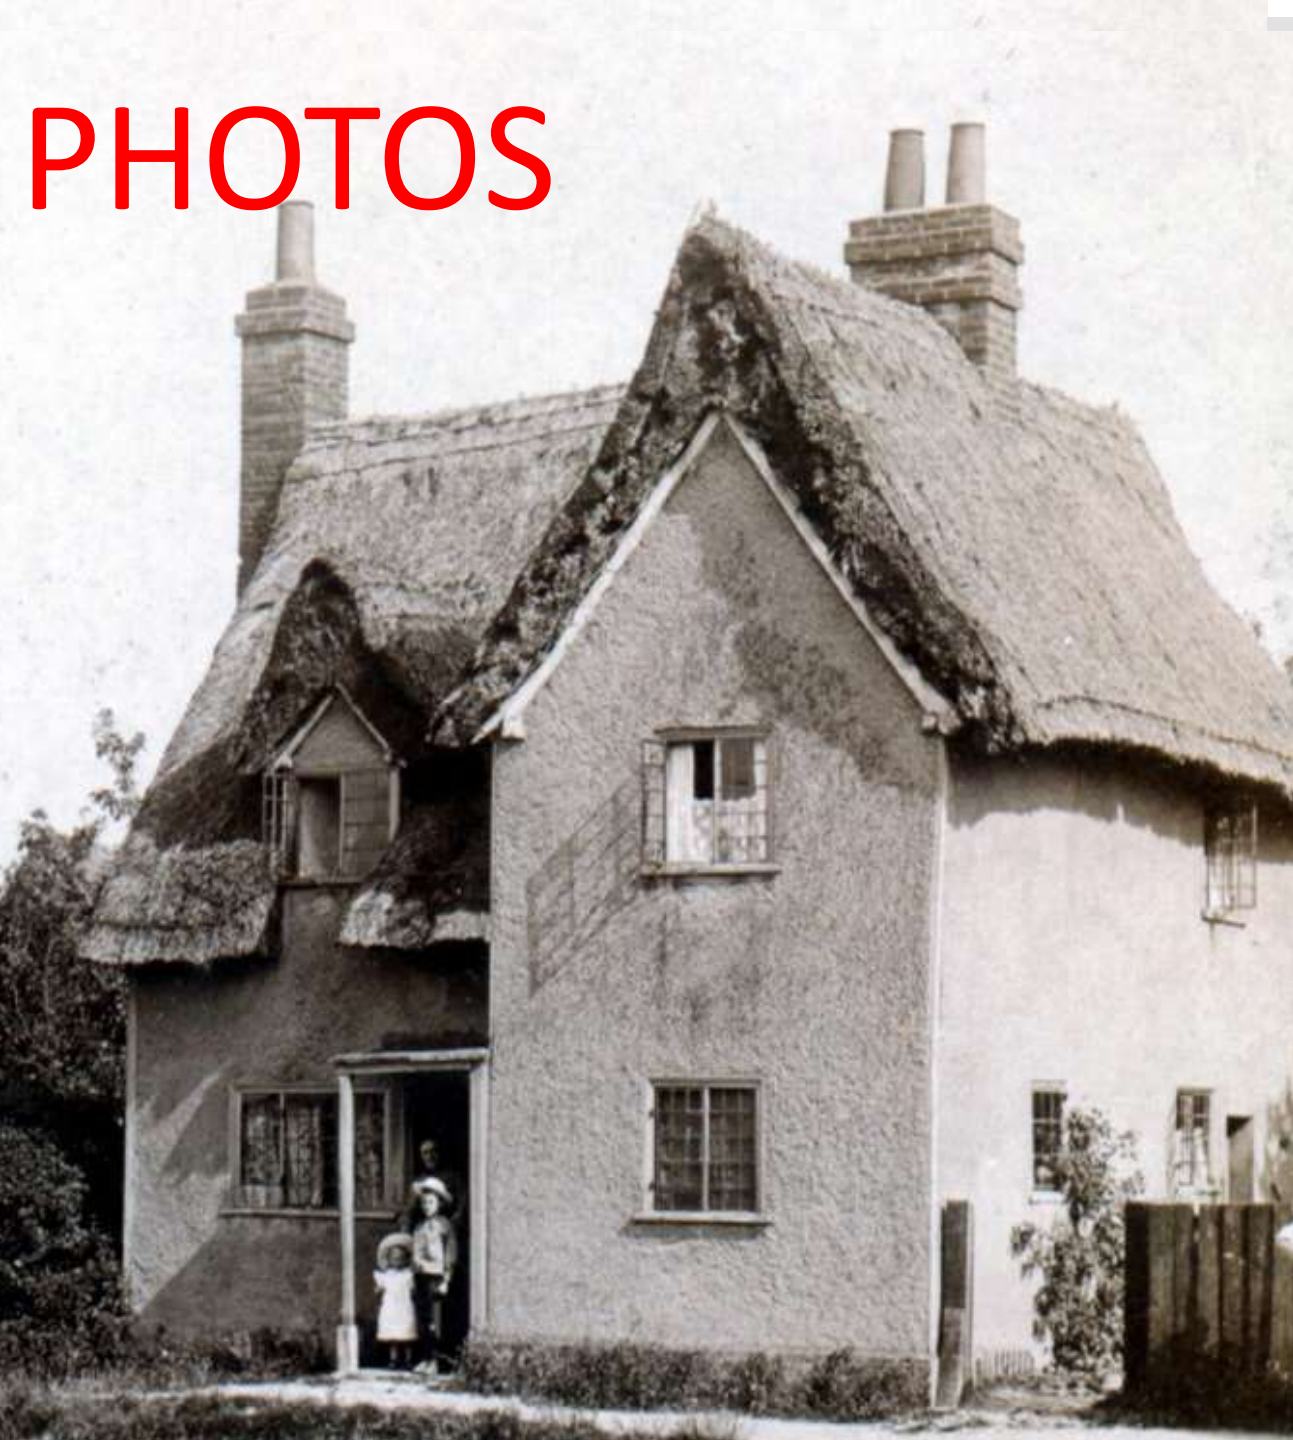
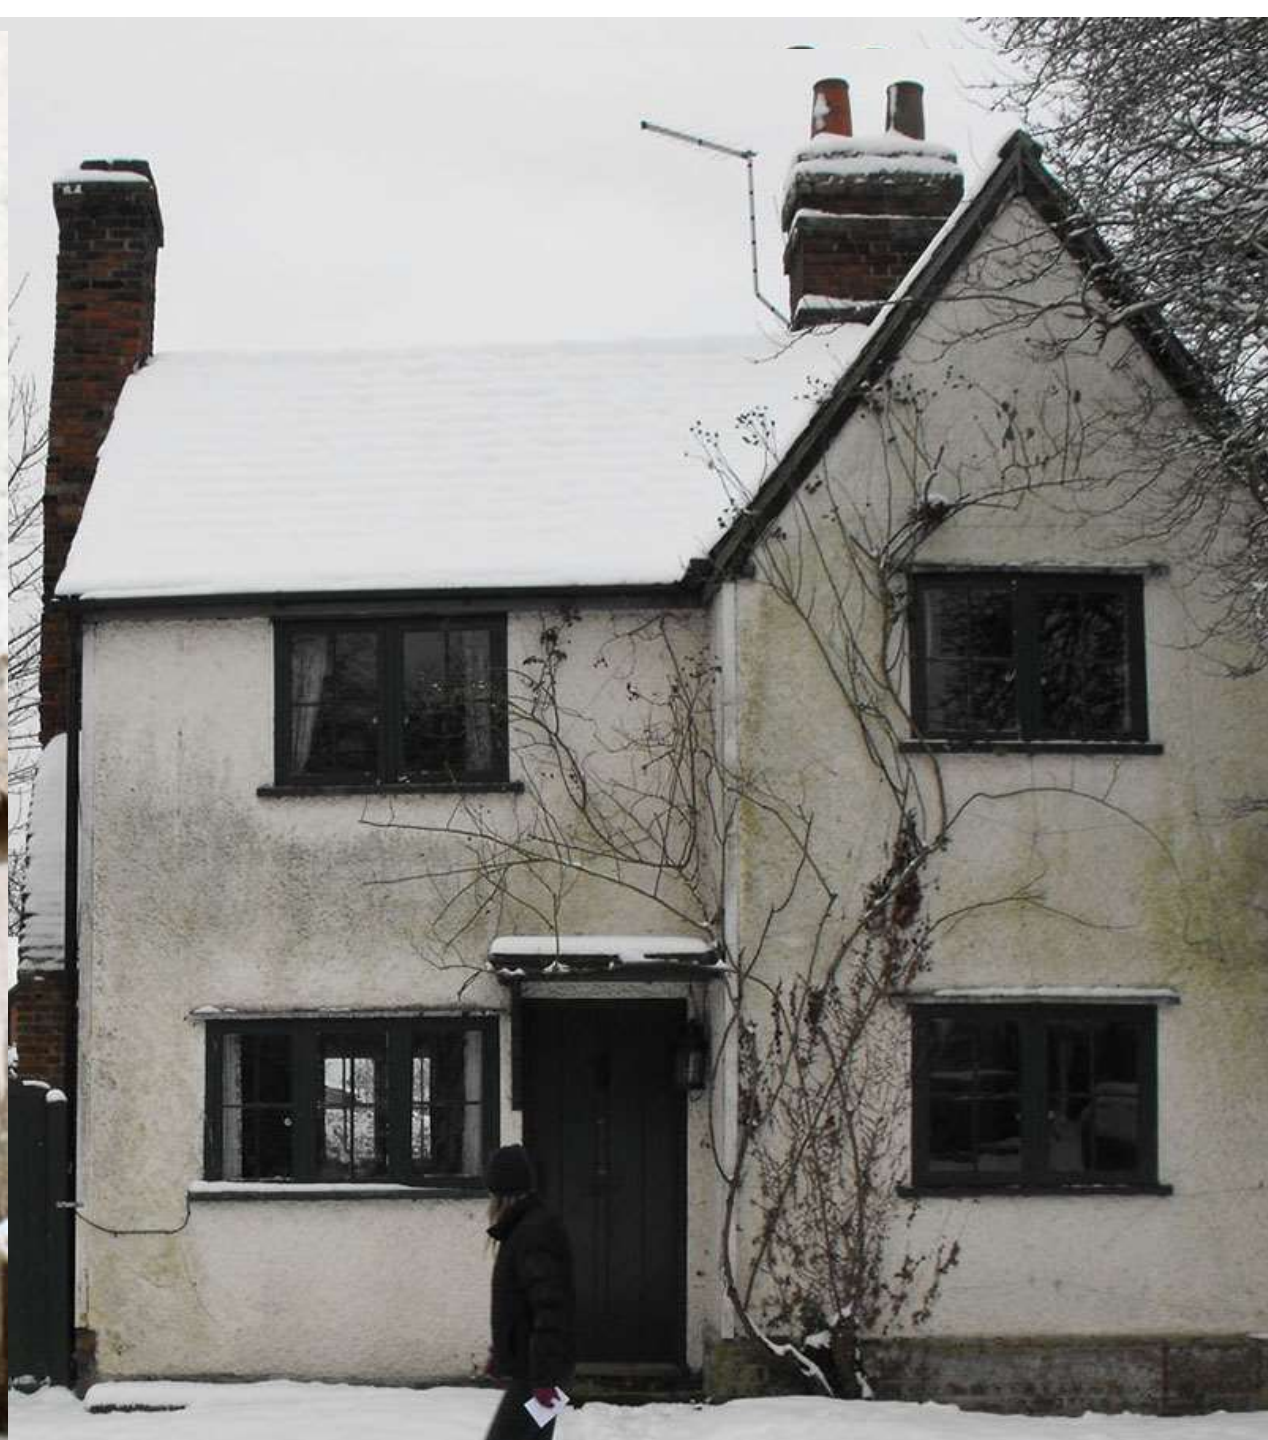
PHOTOS

A timber framed two storey cottage, rendered externally and extended to the rear in the 1970's. Originally thatched, the thatch was removed early in the 20th century and replaced with a slate roof. At the same time the eaves level was raised to the left hand part of the house.

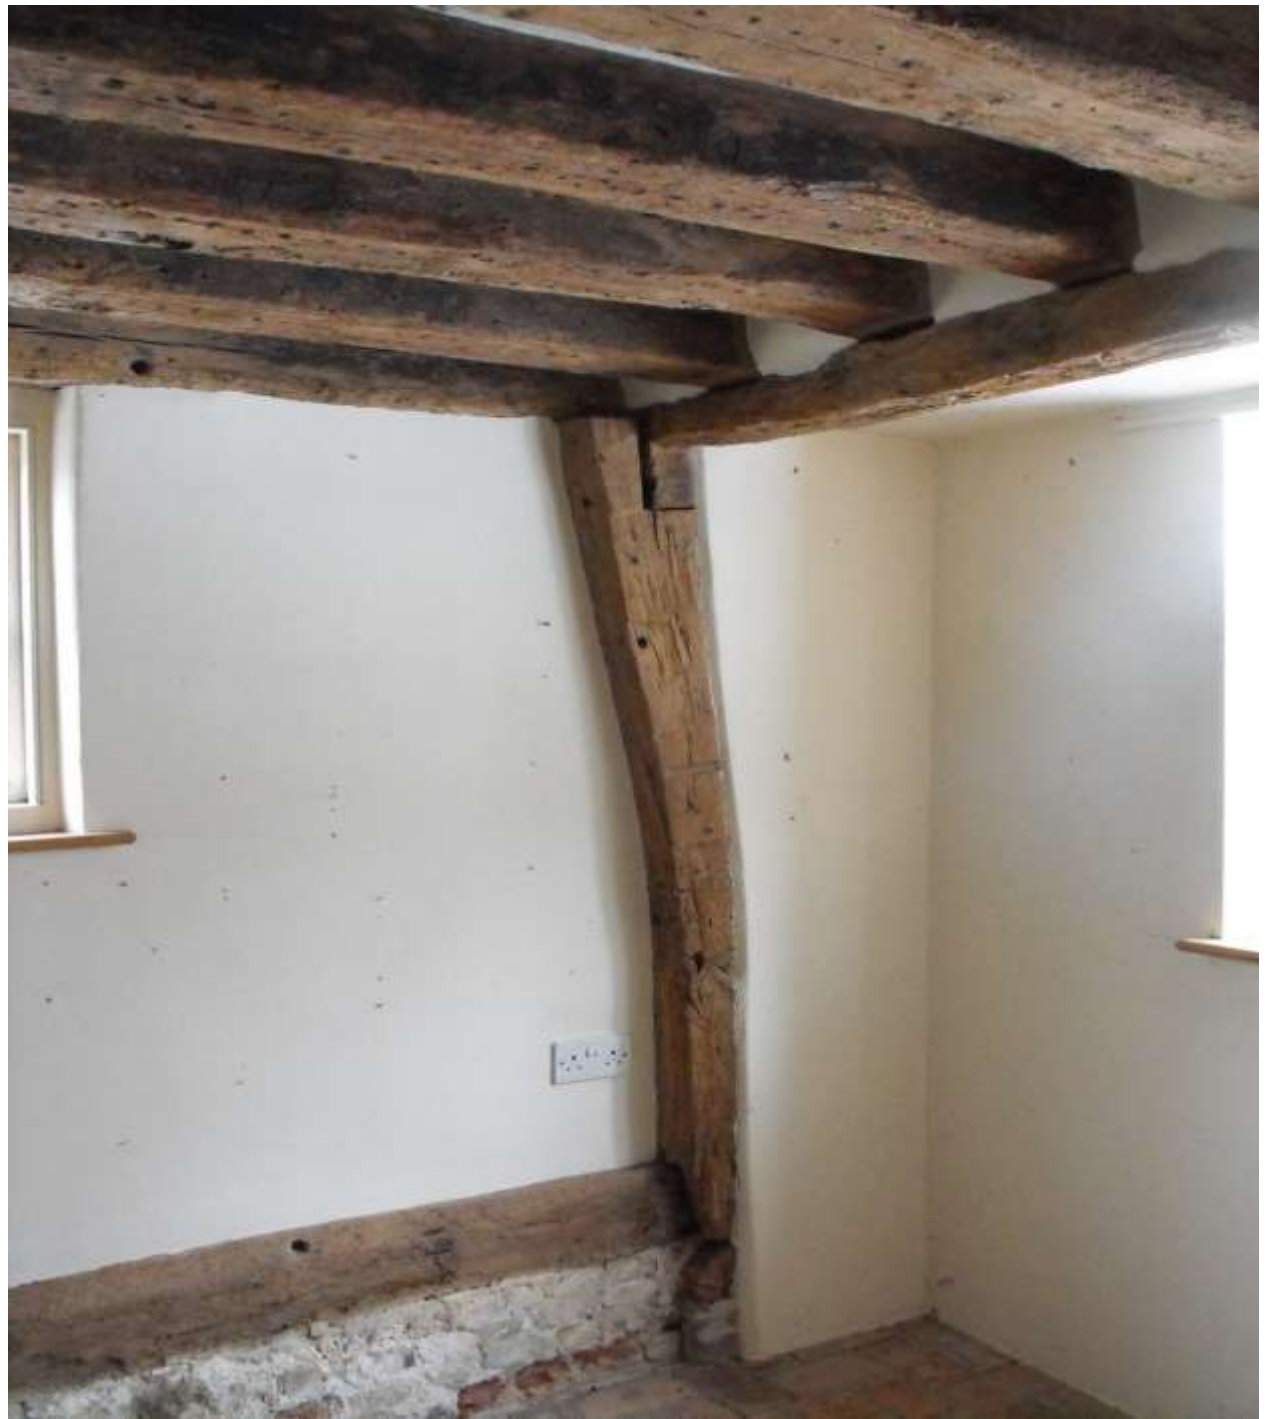
The cross wing was originally jettied. The original corner post can be seen with the sill not extending beyond it. The bressumer beam supporting the first floor joists has been partially cut back to increase head height.

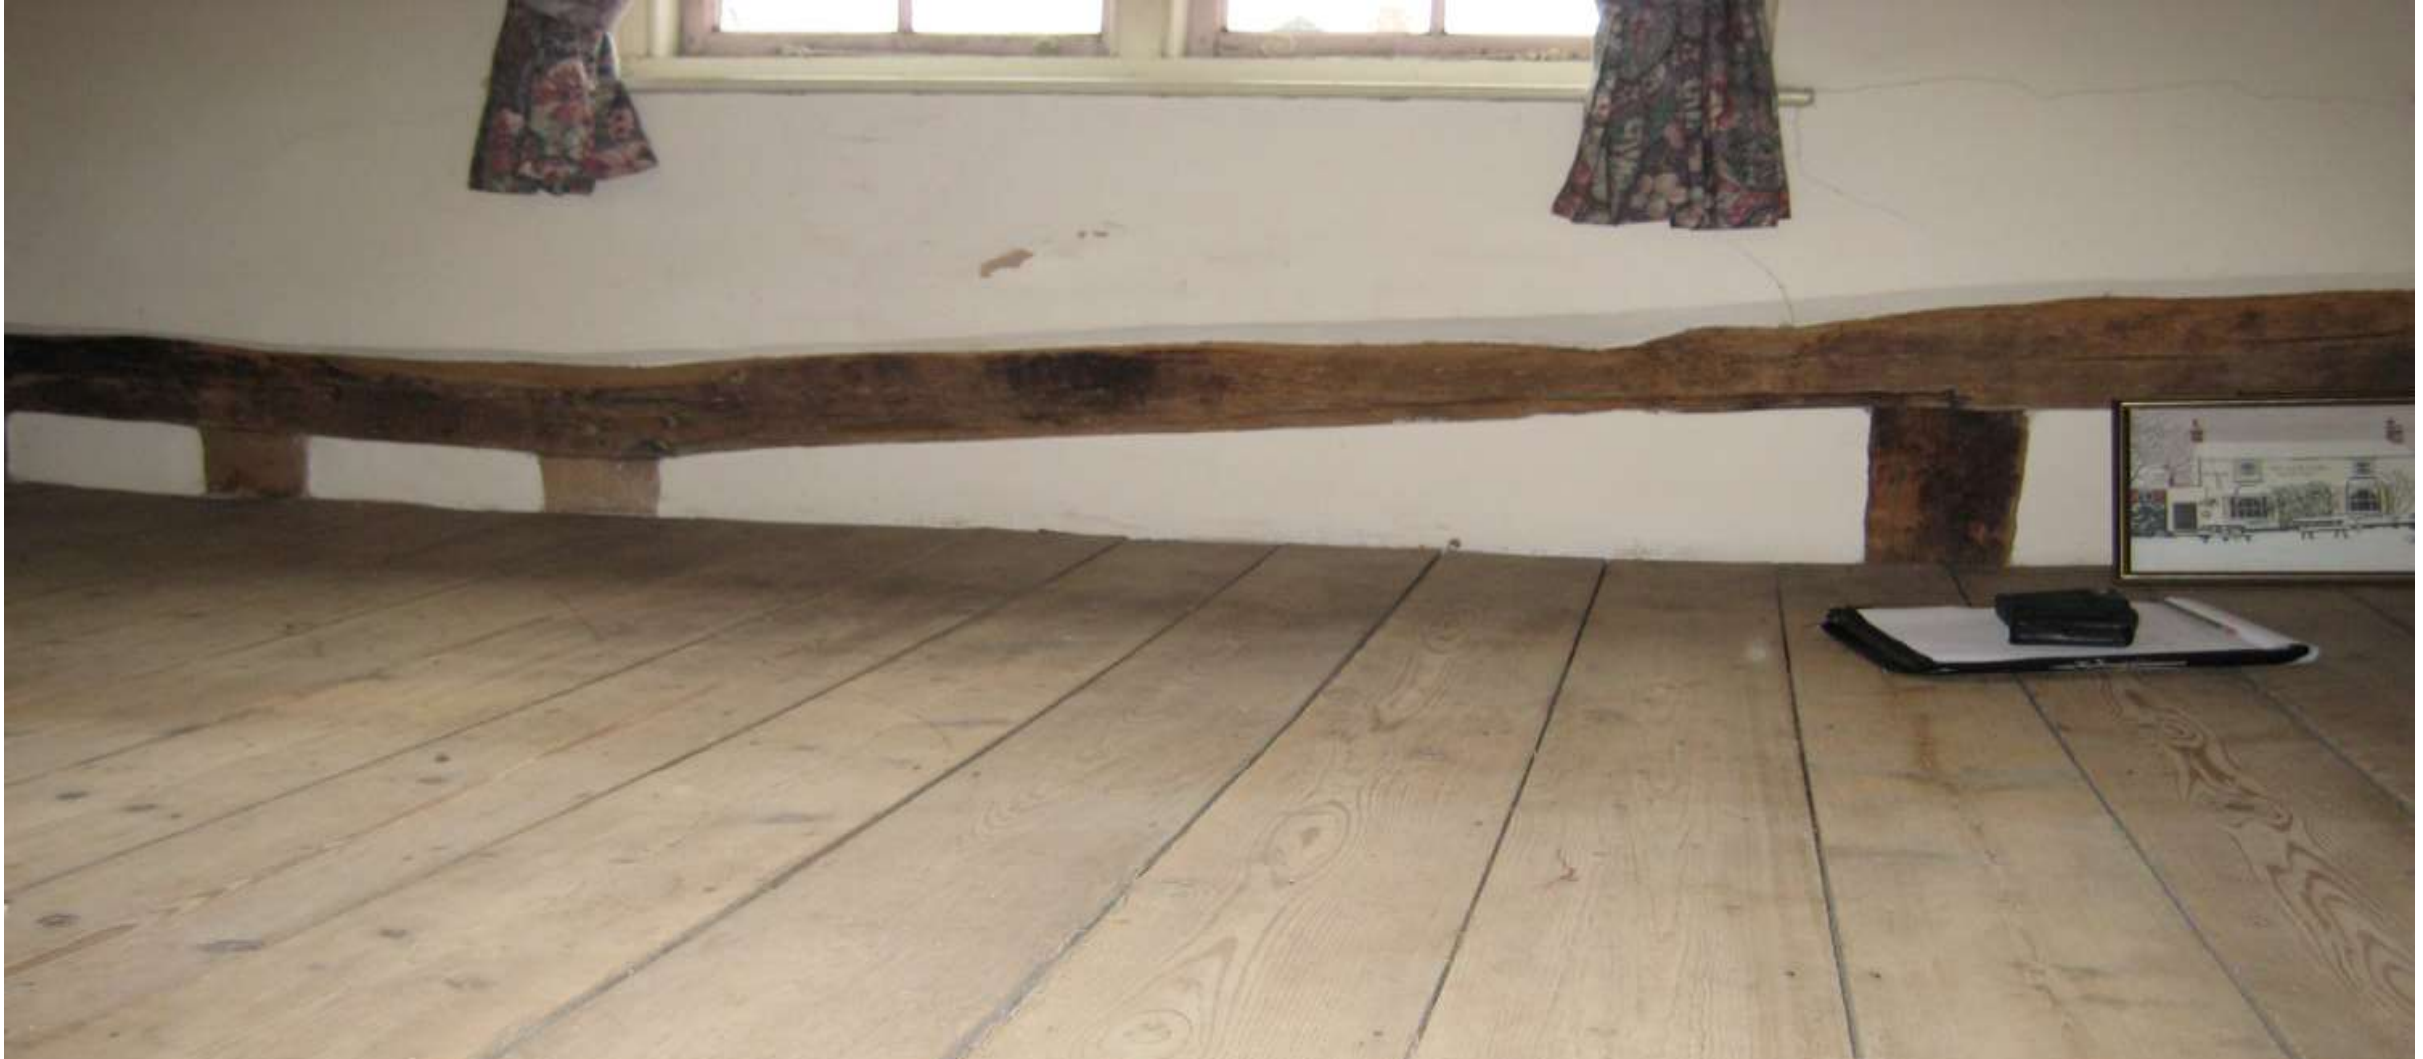
The original wall plate showing the clearly inserted floor. The wide gap in the vertical studs appears to have been the hall window as there is a rebate for shutters. This window is likely to have been timber mullioned and there is evidence of a similar window on the opposite wall.

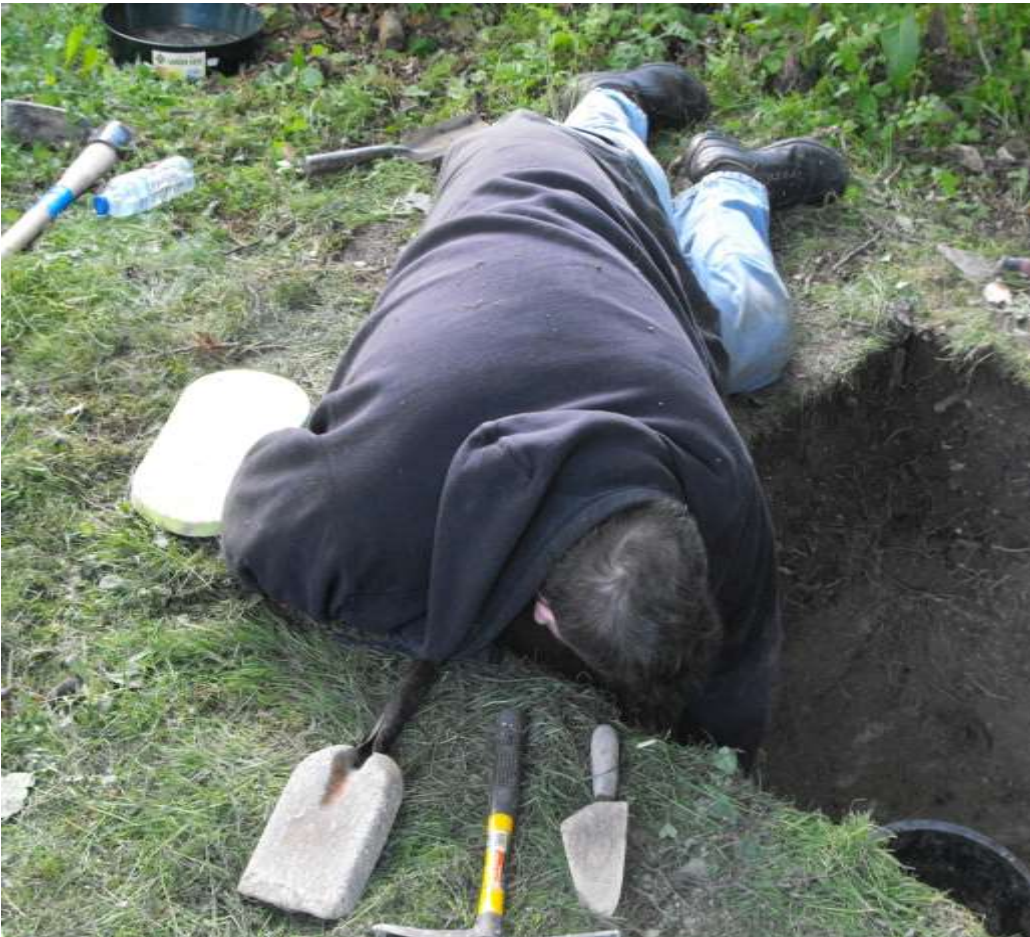
old hand in the pit

Test pitting in the garden over the demolished cross wing produced very little pottery, and large amounts of Victorian ware. This is consistent with the building having remained insitu rather than being demolished and other buildings being erected at a later date on the same site. This is born out by the pre enclosure map of 1800.

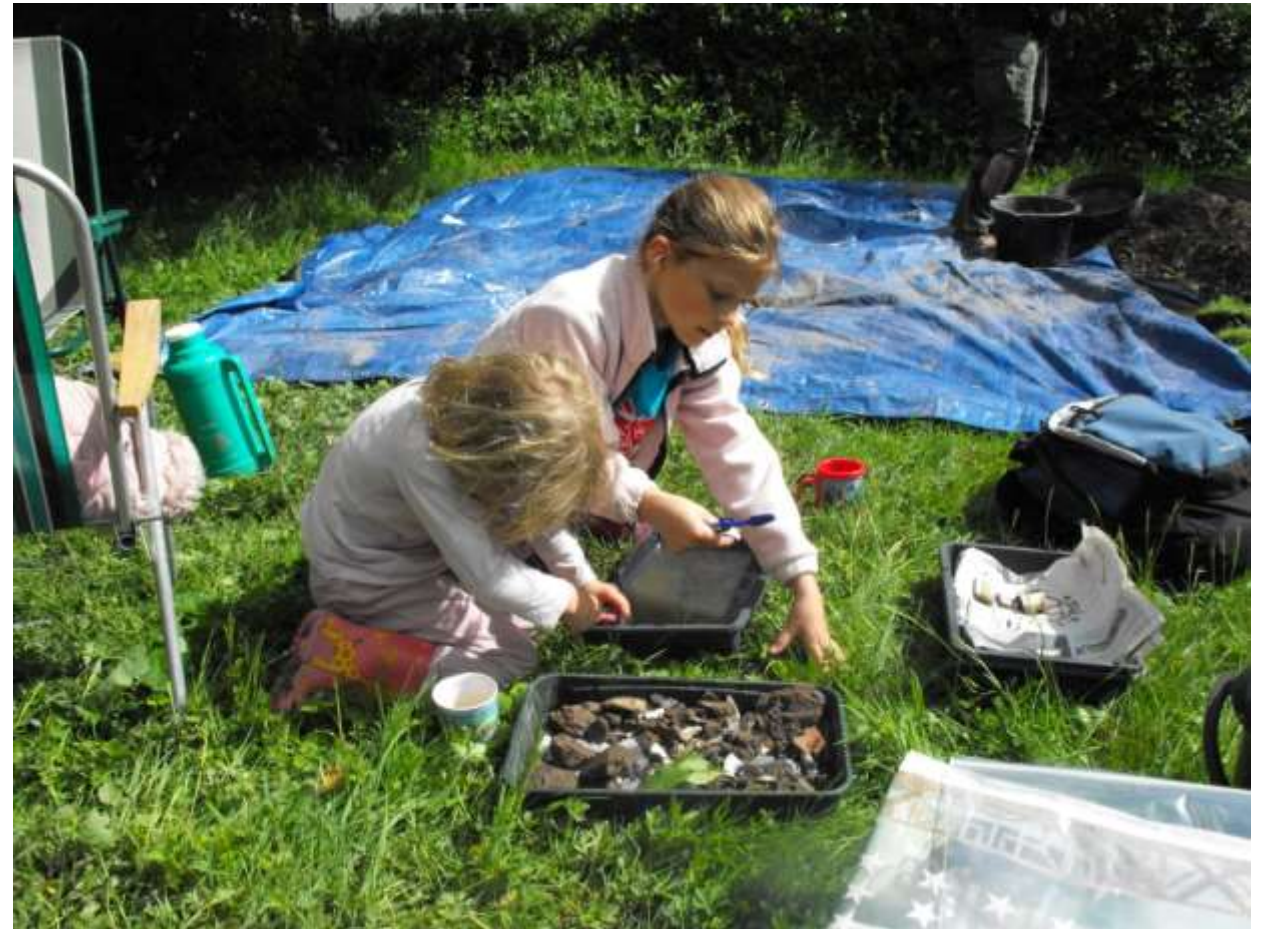
young hands washing the finds

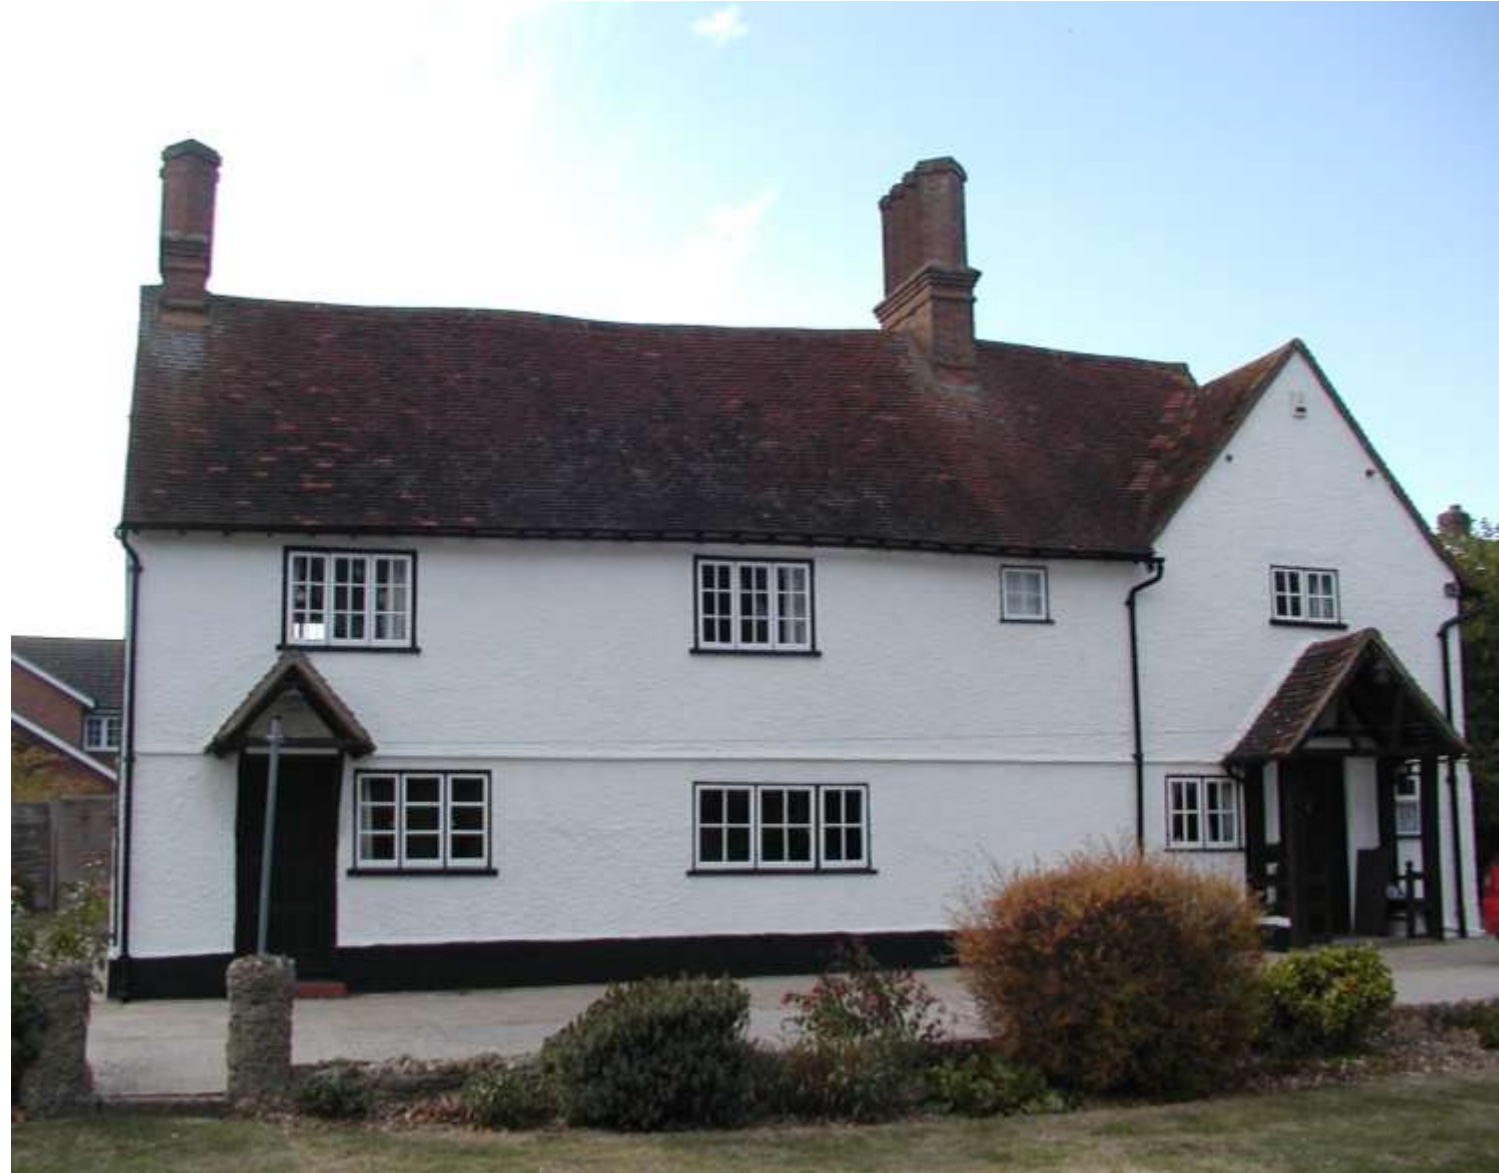
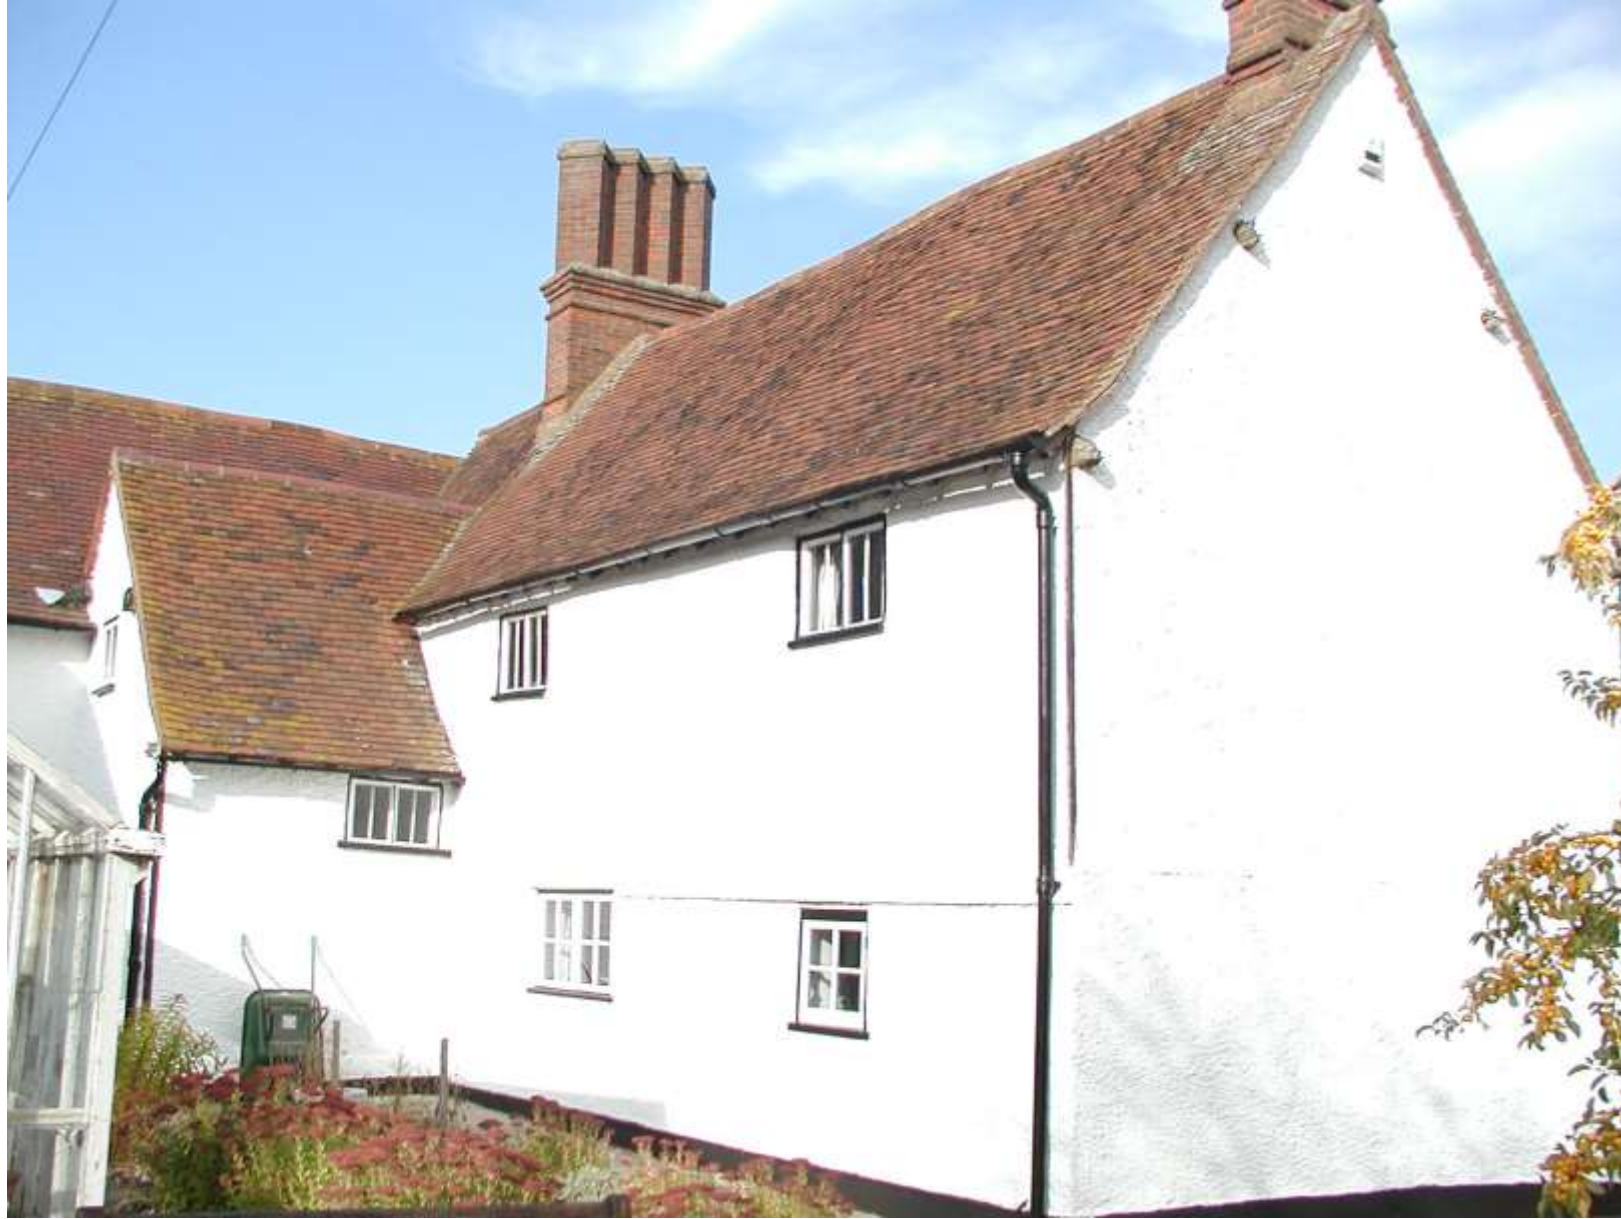
A lobby entrance house dated around 1629. It has 2 and a half bays with a cross wing. The house was built with an upper floor with a brick chimney and a fireplace in the upper chamber. The original entrance would have been in line with the chimney.

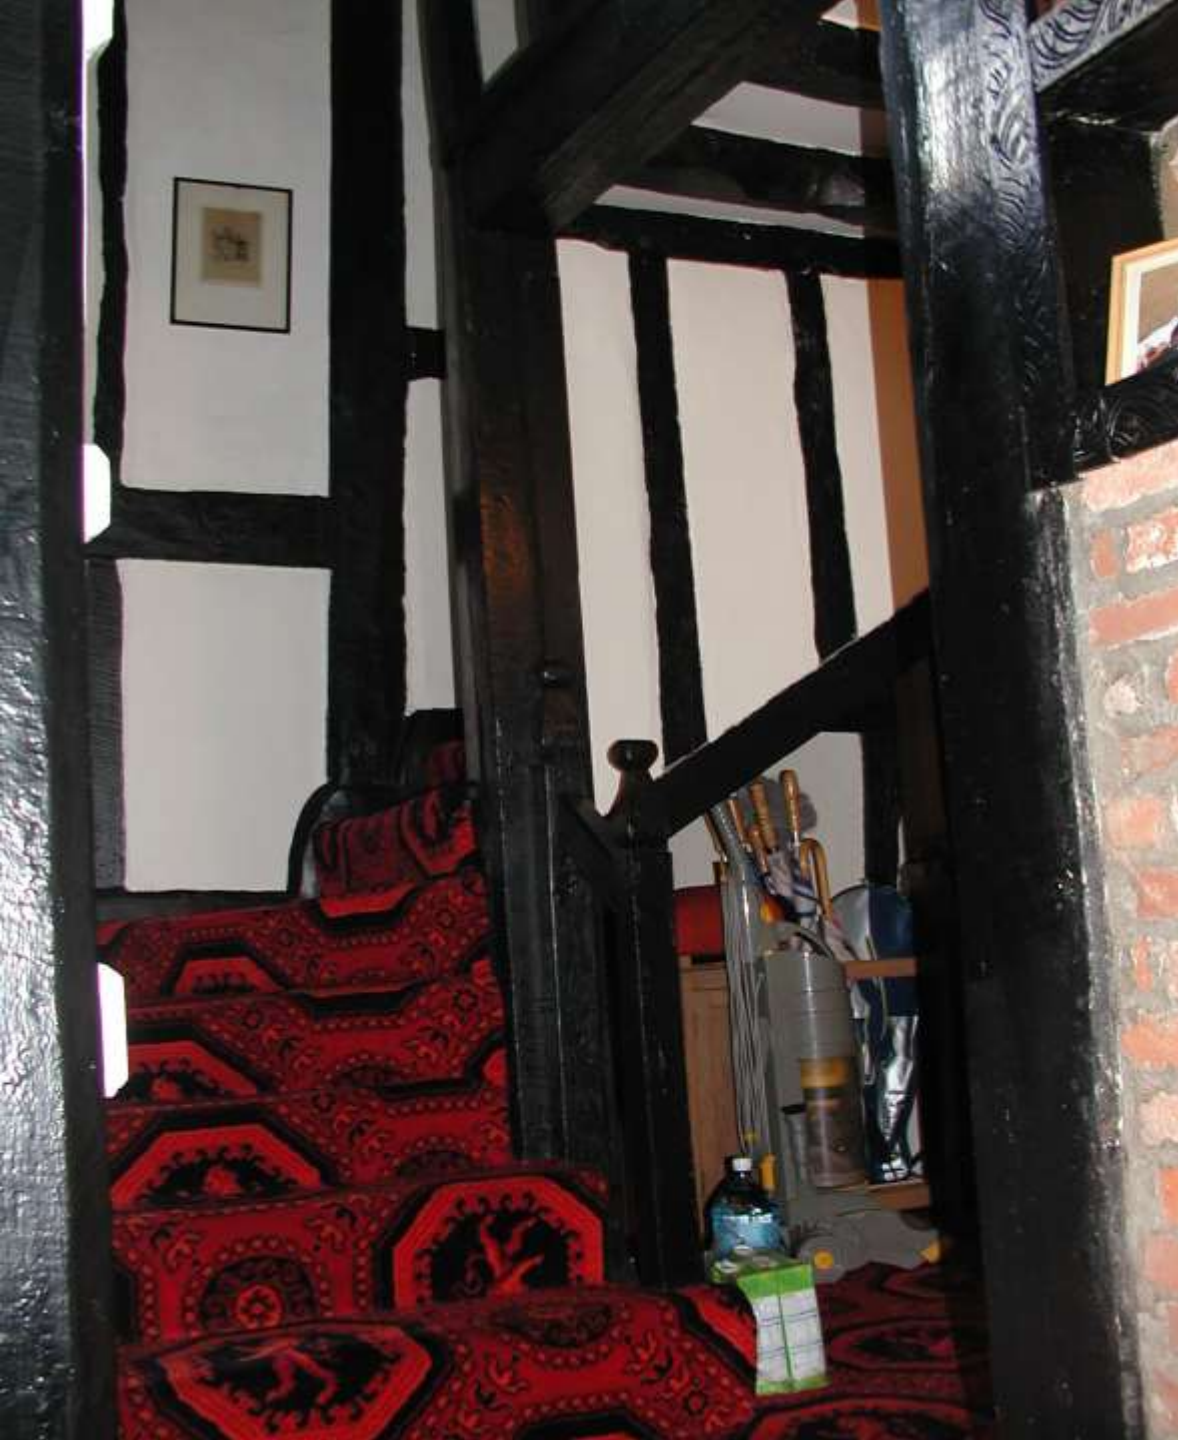
The rear view showing the stair turret. The original staircase was located next to the chimney.

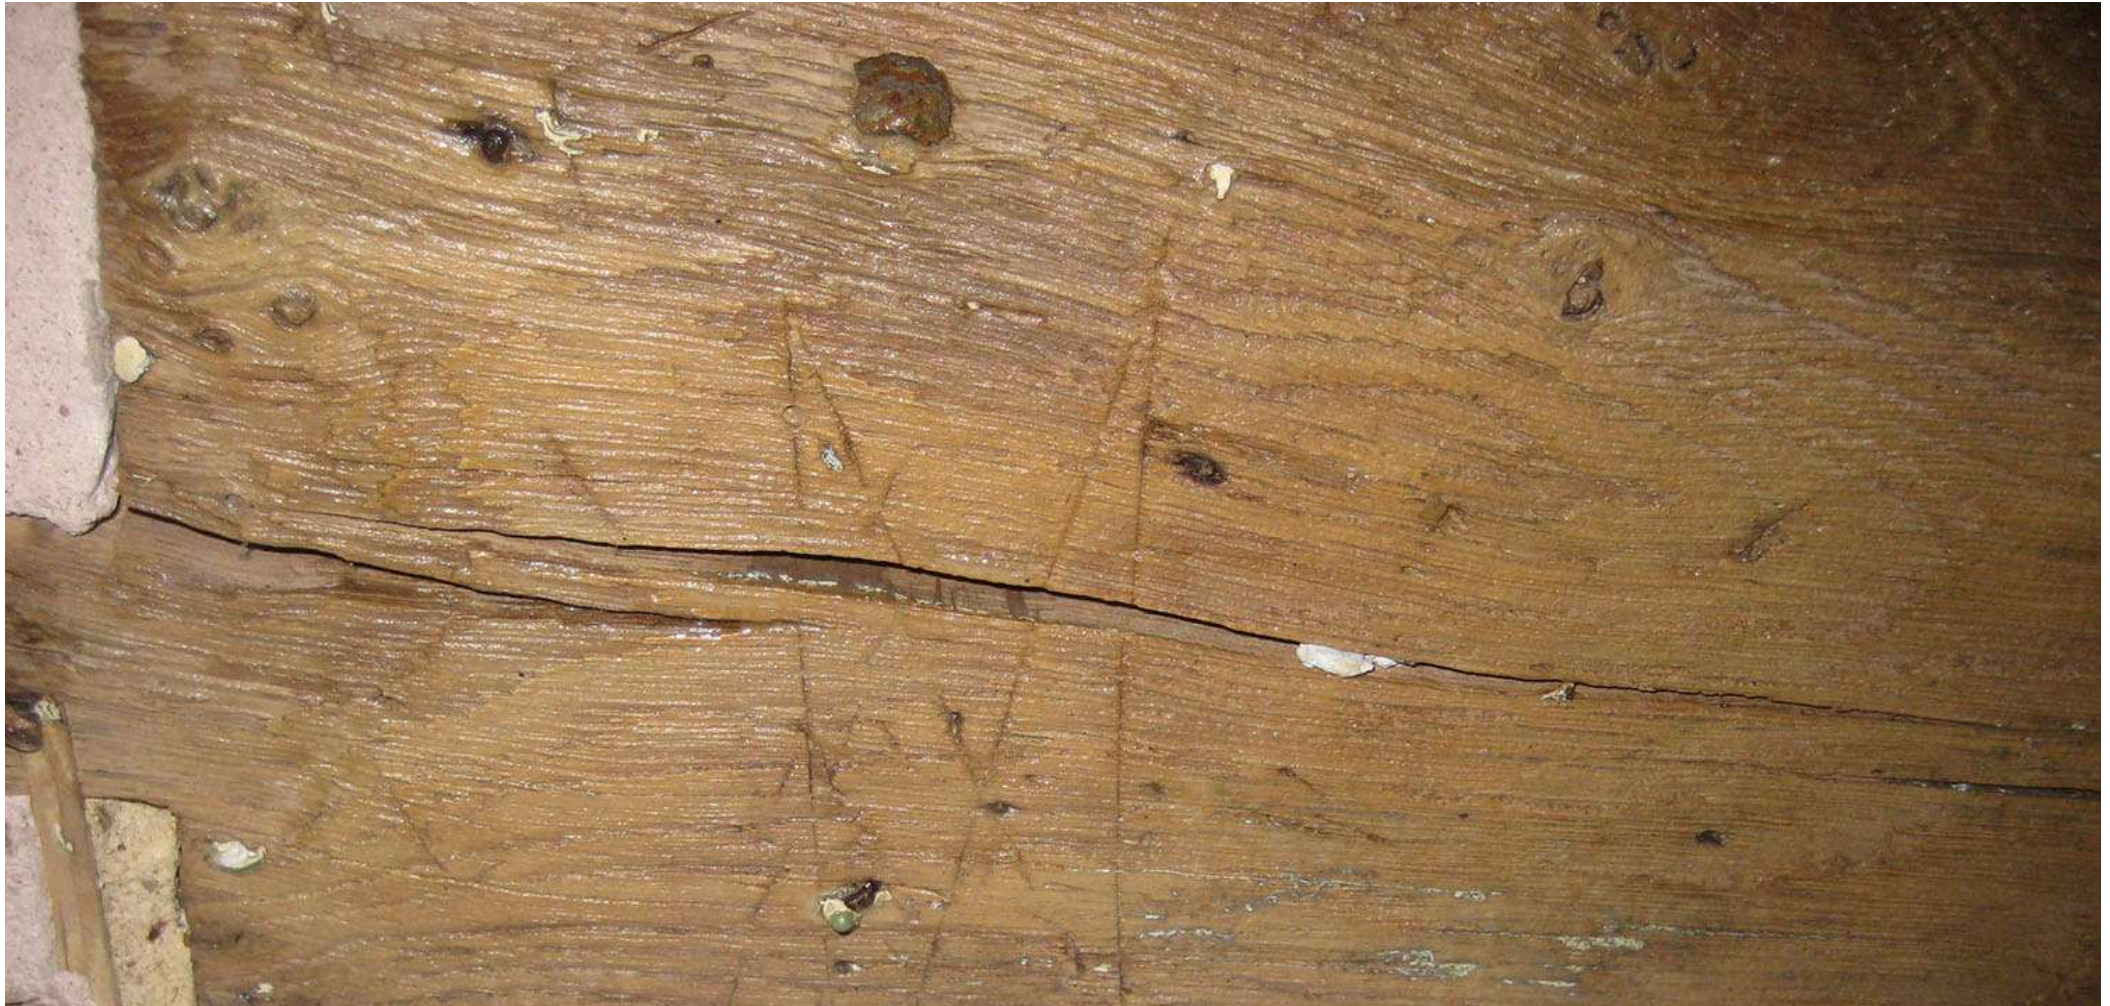
The double V invoking the protection of the Virgin Mary

- One aspect not covered by architecture, formal documents, archaeology etc is peoples beliefs. We have found many apotropaic marks carved into the timbers
- Many of the marks we found were near doors, windows and hearths - areas of buildings vulnerable to evil spirits who were believed to travel through the air

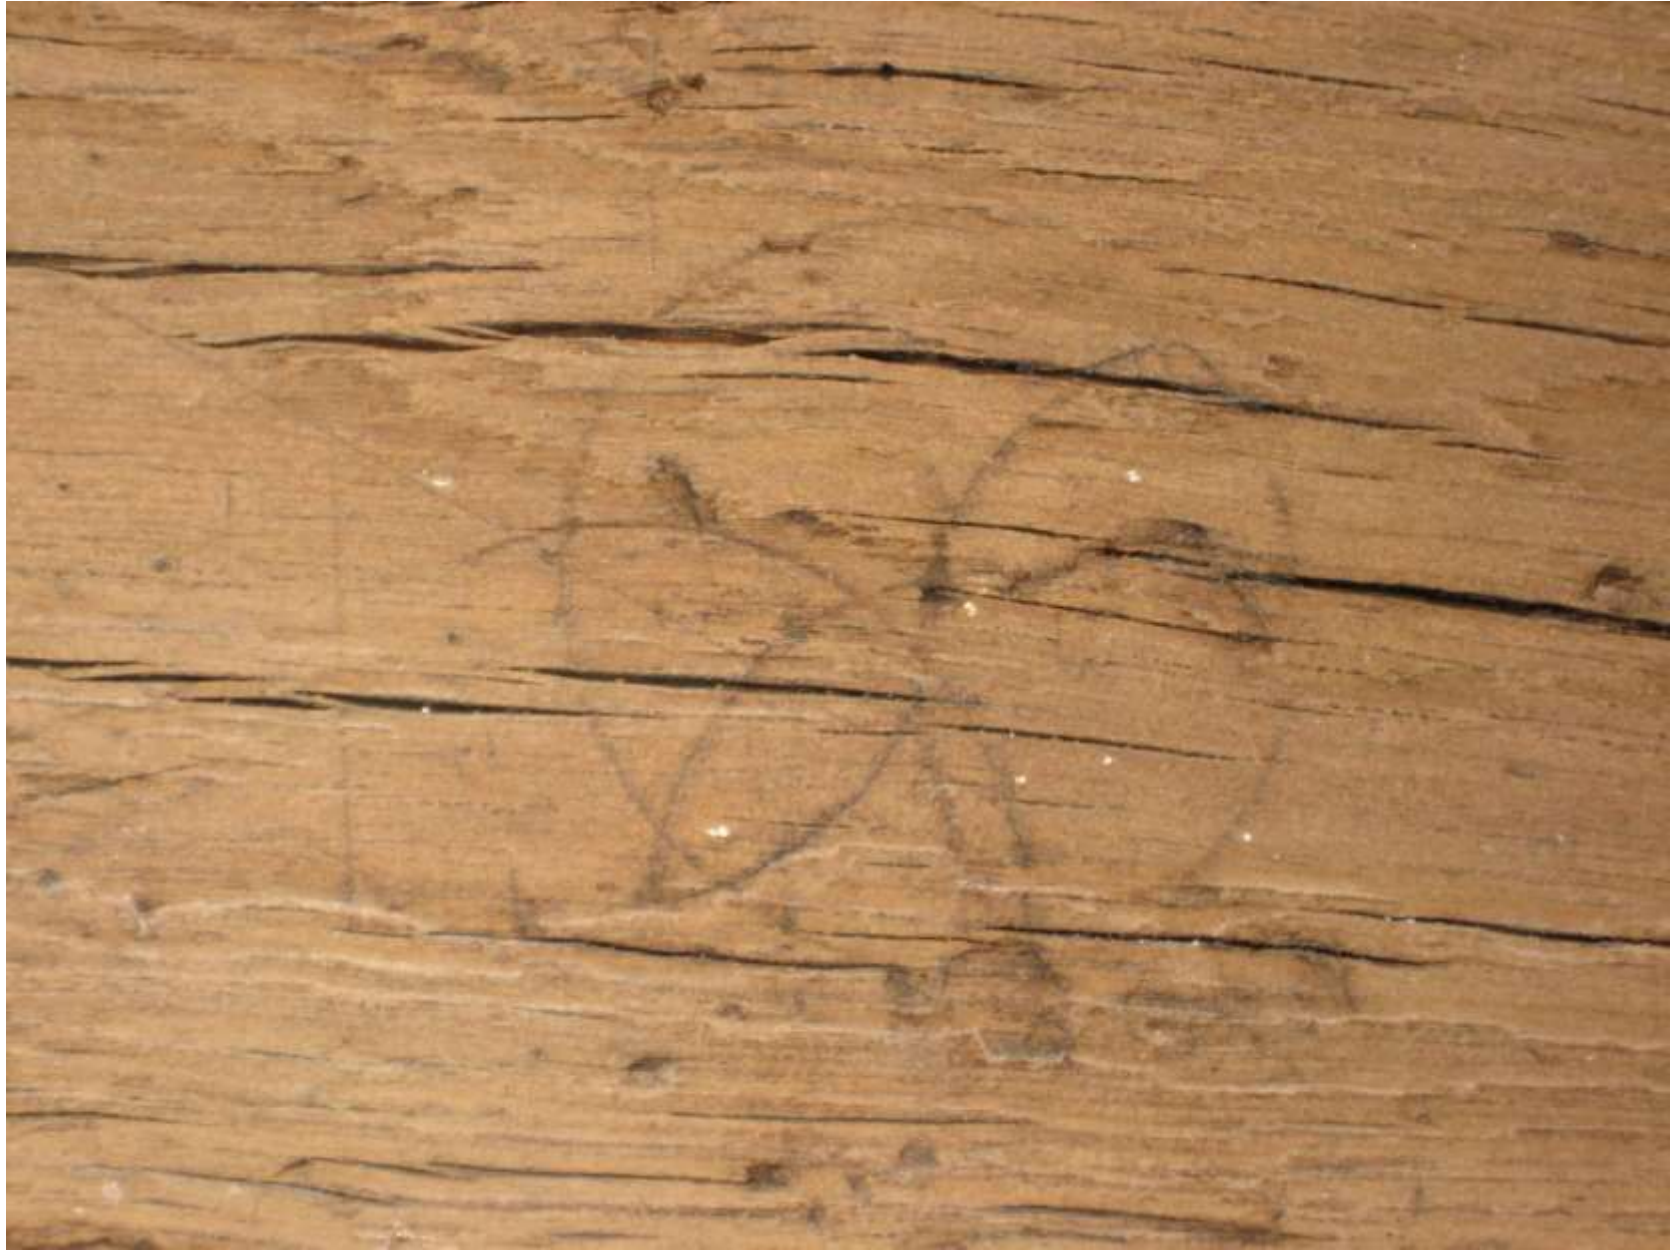
Daisy wheel found mainly in kitchens

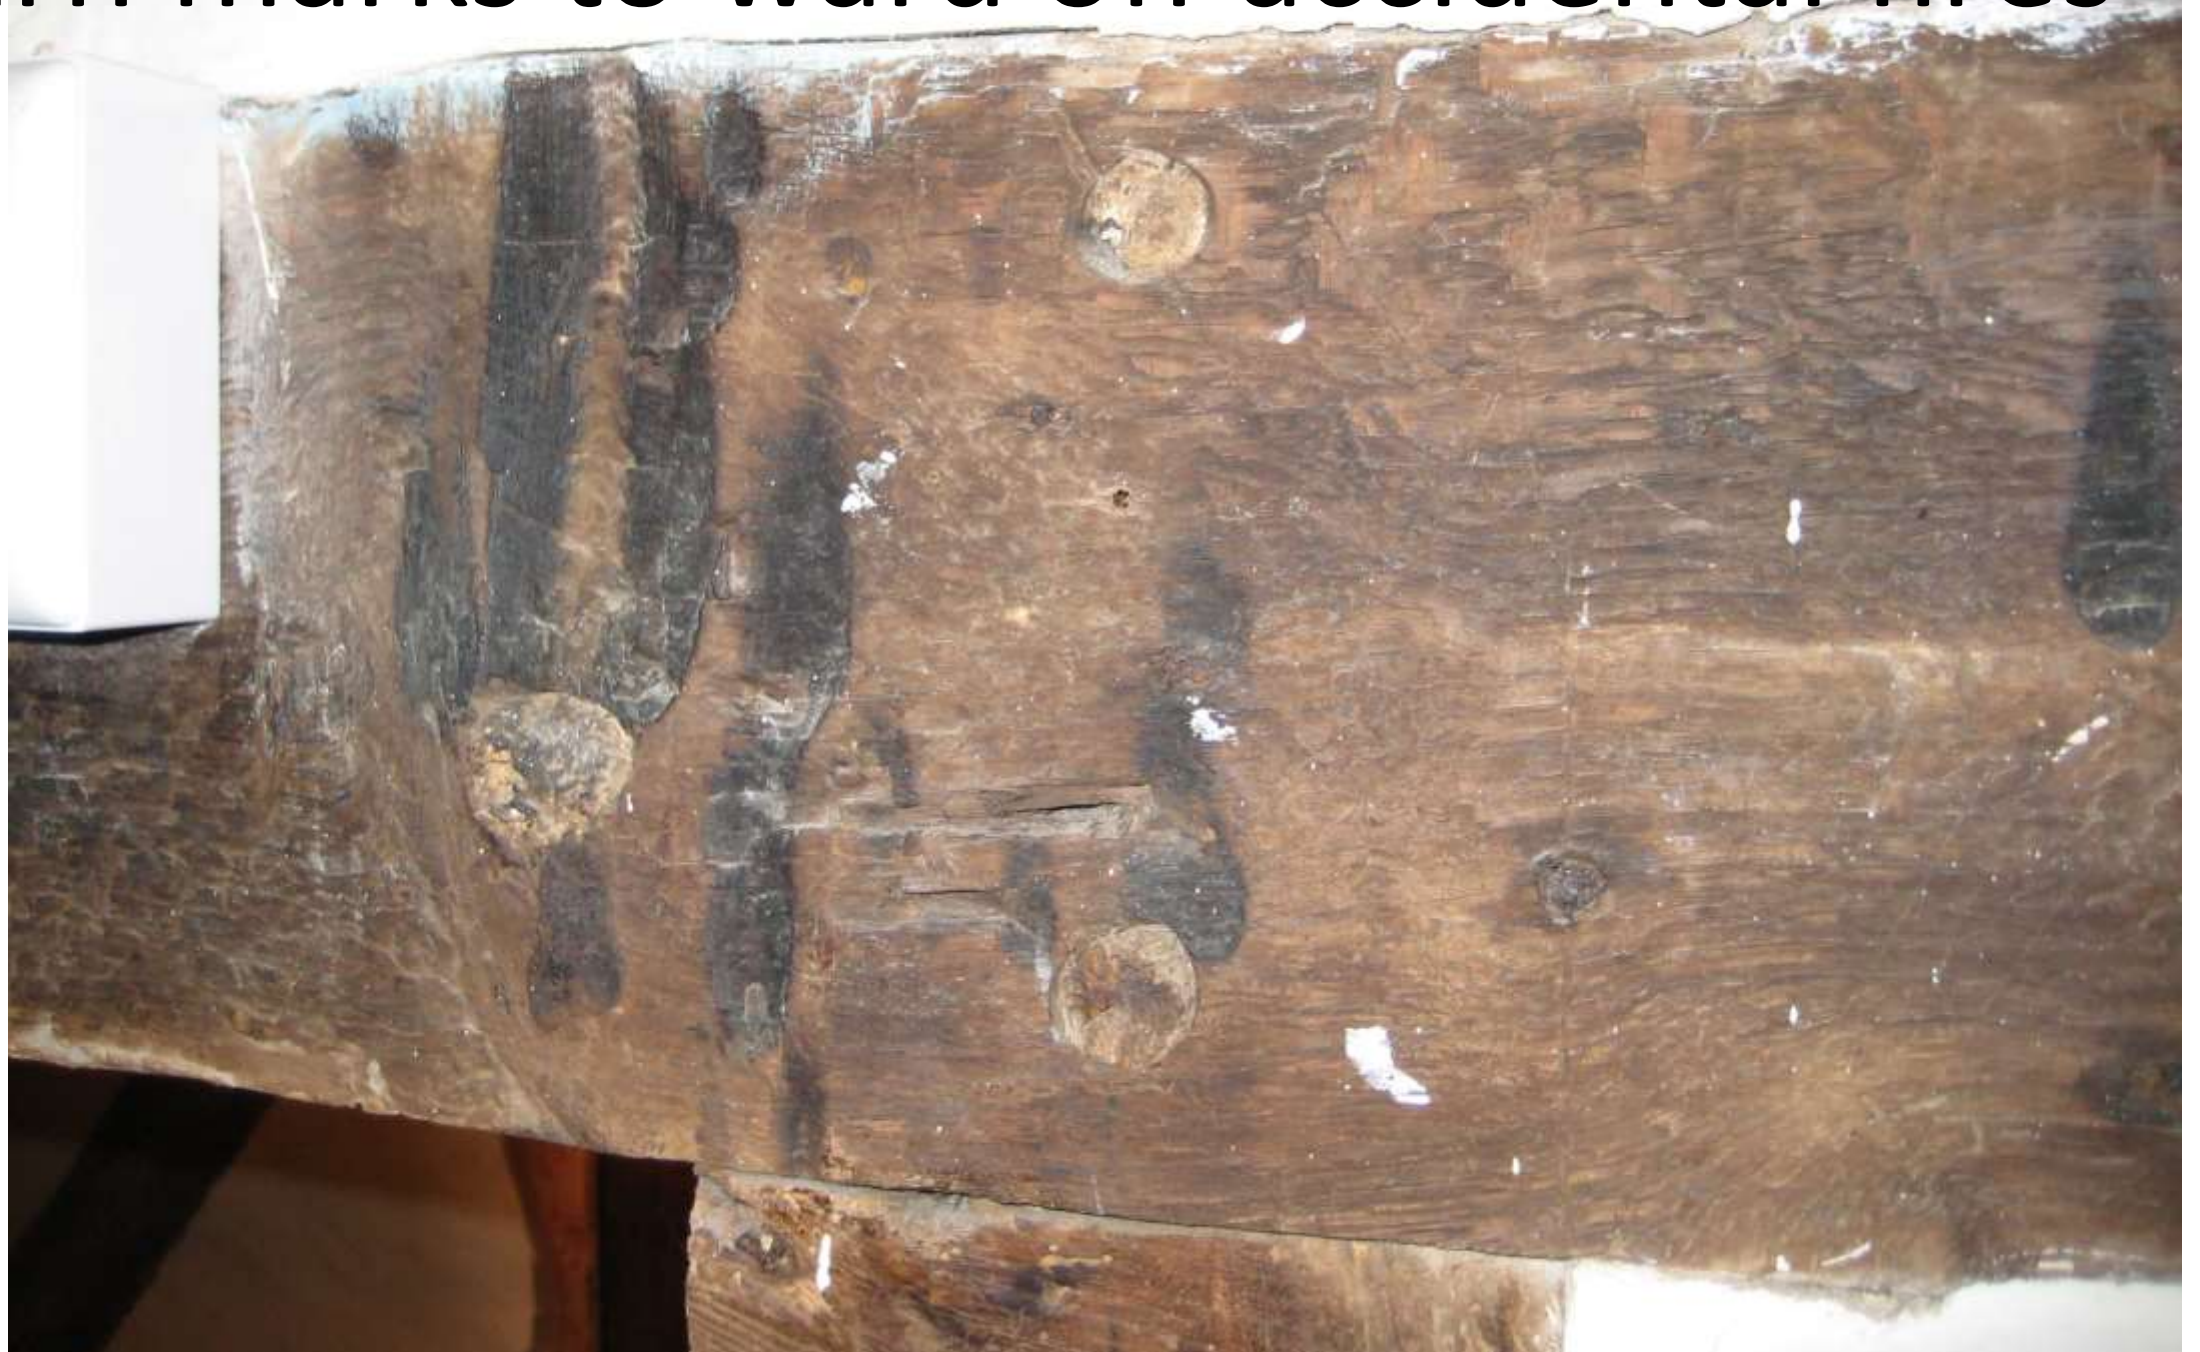
Burn marks to ward off accidental fires
