# Pirton. The Bury

## 1: Introduction

KJM February 1989  
North Herts Museums

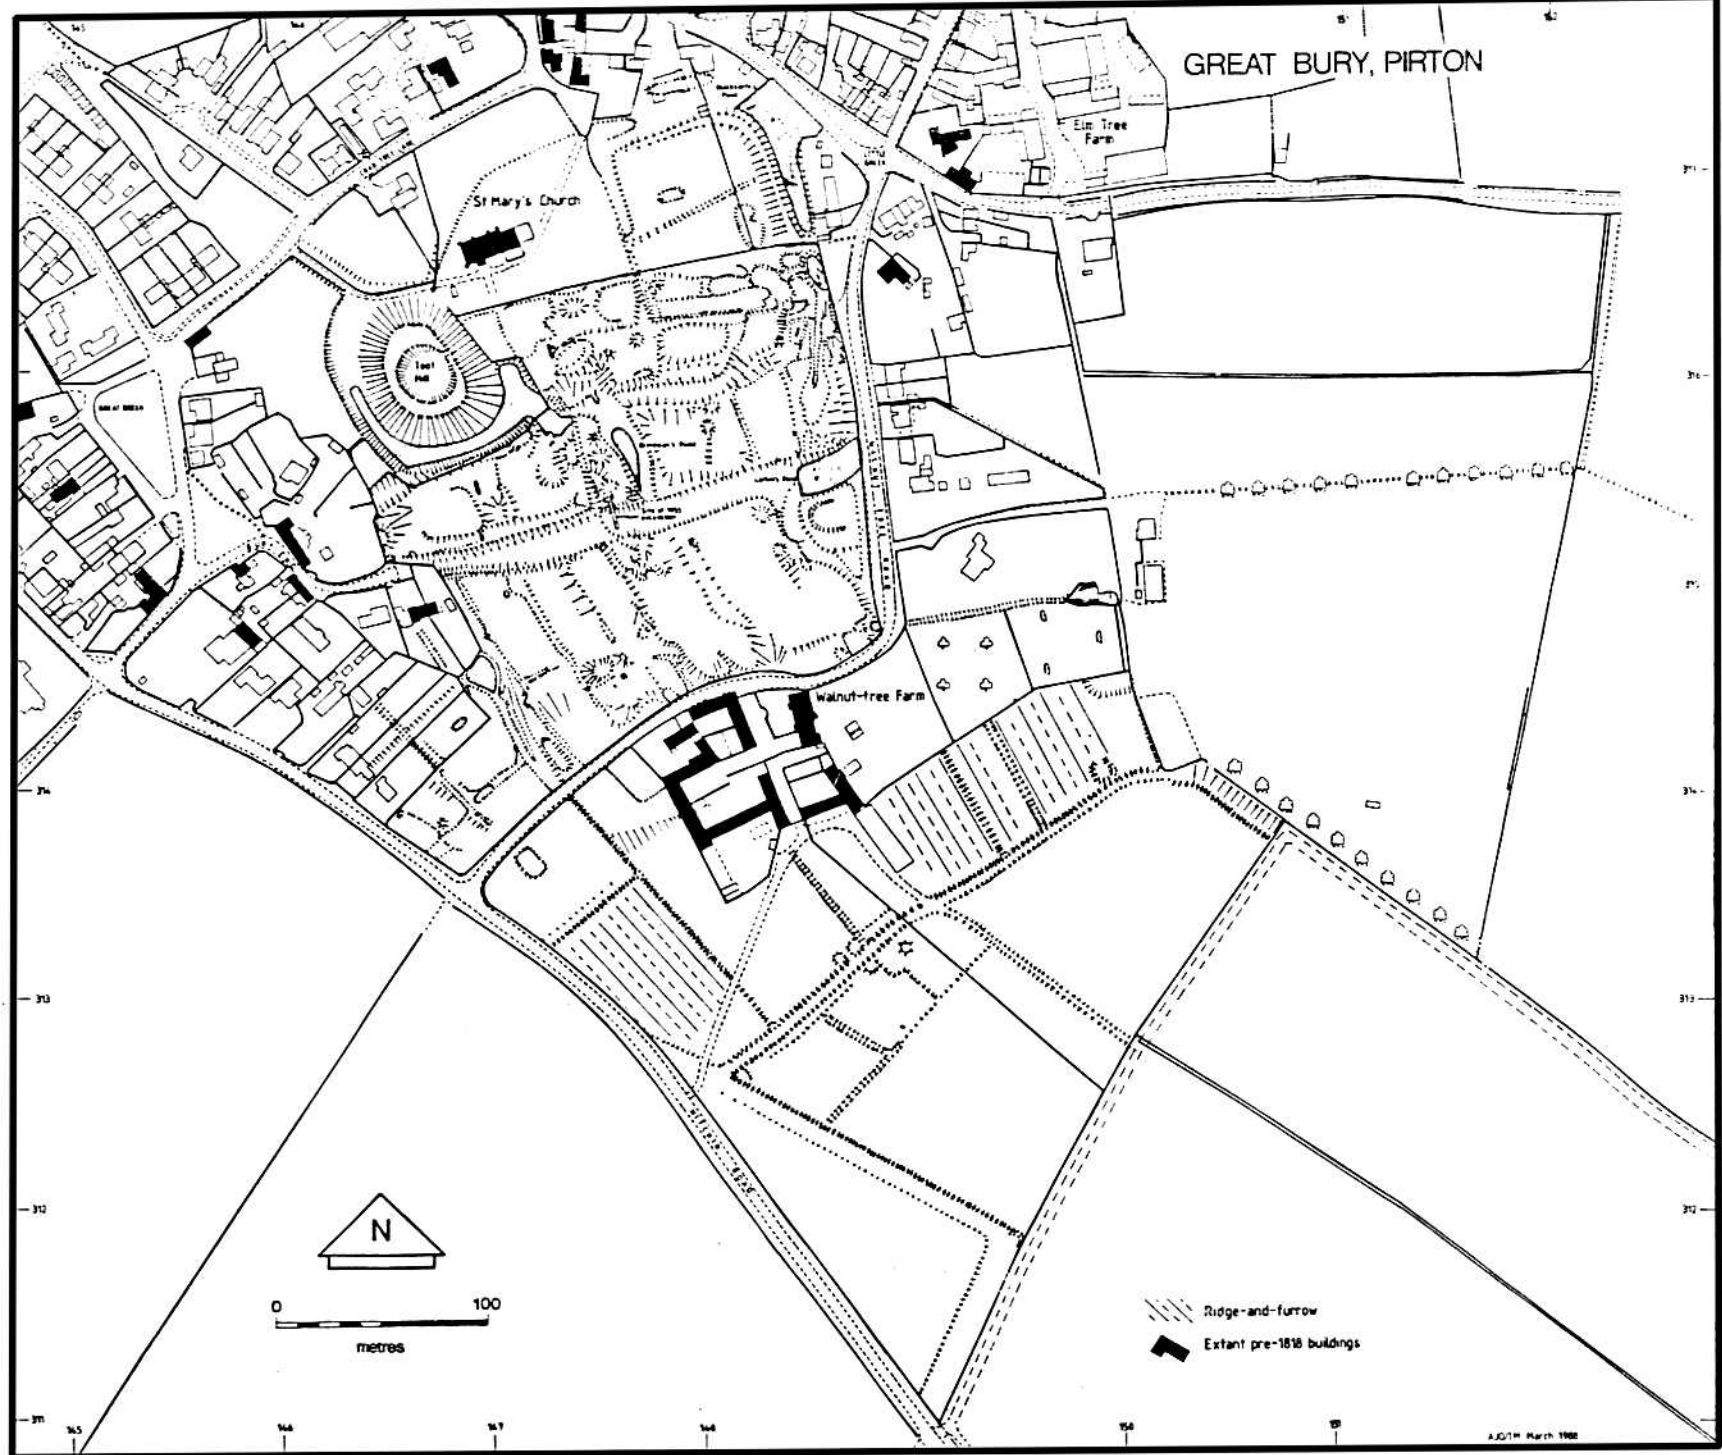
# GREAT BURY, PIRTON

Because of the size of the area to be surveyed (over 4.5ha) it was decided that the quickest method would be to produce scale drawings in the field at 1:500 by means of an offset survey. Two base lines were laid out at right angles by theodolite, using wooden pegs spaced at 50m intervals except in one instance where the presence of the deep pond known as Blind Pond or Blindman's Pond made the location of a peg impossible. The field was thus divided into four unevenly sized segments. Grid north was determined as 321°30' magnetic using a prismatic compass.
